**Flood Control Project Maintenance  
Levee Inspections**  
**LMA District Cover Sheet**  
**Spring 2020 Levee Inspection Results**

**Merced Streams Group**

**Spring 2020 Levee Inspection Results**

Waterway			Bank	Unit Miles
Unit No. 01 Black Rascal Diversion			Right	1.61
	Spring (March - May)	Summer (June - August)	(September - November) Fall	Winter (December - February)
Unit Maintenance Rating (Fall Only)				
Date of Inspection	4/16/2020 - 4/16/2020			
DWR Inspector	Corey Fujitani			
Accompanied By	Oscar Ortiz Merced County

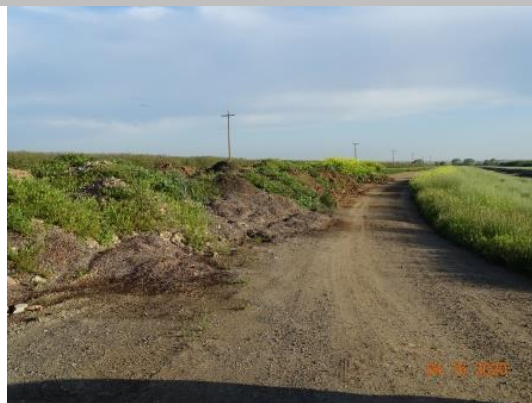
Photo 1 of 1 : SP\_2020\_NA0013\_331\_13\_20200505\_00019.jpg

Material pile left on landside shoulder and crown. (Spring 2020)

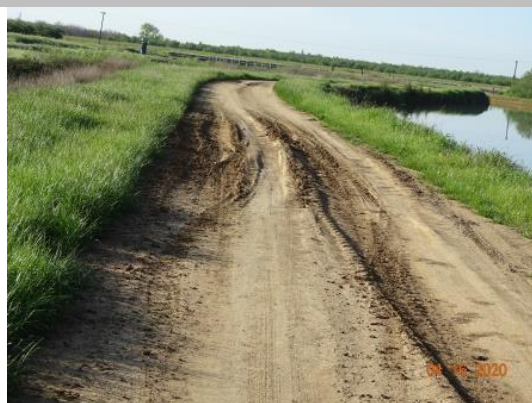
Photo 1 of 1 : SP\_2020\_NA0013\_331\_8\_20200505\_00017.jpg

LM Start	0.27	Rating **	M	Issue No.	8
LM End	1.62	Issue Type +	Ma	Location *	CR
Category	Earthen Levee			GPS Latitude/Longitude	
				Start	End
Item	Crown Surface / Depressions / Rutting			37.318525 °	37.337176 °
				-120.396598 °	-120.396531 °
DWR ID	DWR_NA0013_01_s_2018_8				
Comment Code					
C2 : Repair depressions or ruts in the crown or slope.					
Inspector Comment					
Vehicle tracks and rutting on the crown should be repaired.

View of vehicle tracks on the levee crown. (Spring 2020)

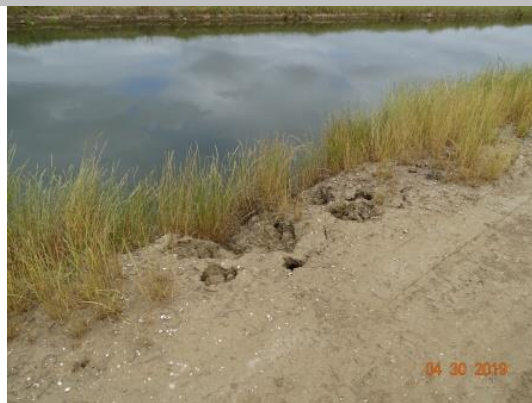
Photo 1 of 1 : SP\_2020\_NA0013\_331\_14\_20200225\_00009.jpg

View of erosion on landside slope. (Spring 2019)

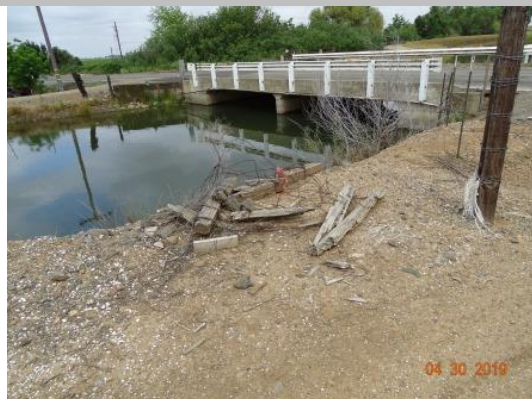
Photo 1 of 1 : SP\_2020\_NA0013\_331\_16\_20200225\_00010.jpg

LM Start	1.23	Rating **	M	Issue No.	16
LM End	1.23	Issue Type +	Ma	Location *	CR
Category	Earthen Levee			GPS Latitude/Longitude	
				Start	End
Item	Repair Gates			37.332005 °	37.332005 °
				-120.394751 °	-120.394751 °
DWR ID	DWR_NA0013_01_s_2019_16				
Comment Code					
Inspector Comment					
Gate has been removed.

View of barbed wire gate discarded on levee. (Spring 2019)

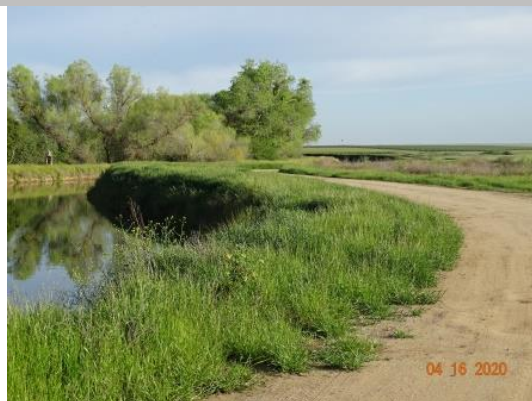
Photo 1 of 1 : SP\_2020\_NA0013\_331\_21\_20200505\_00018.jpg

LM Start	1.25	Rating **	U	Issue No.	21
LM End	1.57	Issue Type +	Ma	Location *	LS
Category	Earthen Levee			GPS Latitude/Longitude	
				Start	End
Item	Vegetation			37.332325 °	37.336558 °
				-120.394727 °	-120.396542 °
DWR ID	DWR_NA0013_01_s_2020_21				
Comment Code					
V1 : Control annual grass and weeds on the levee slopes and easements.					
Inspector Comment

Control the vegetation on the landside shoulder. (Spring 2020)

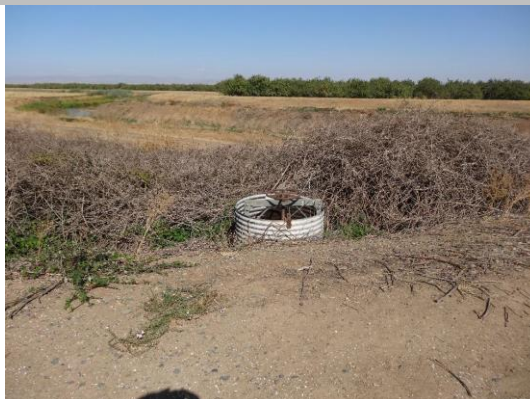
Photo 2 of 3 : UCIP\_SP\_2020\_41672\_35210.jpg

Comment Code						
Inspector Comment						
DS_ID:23079 FS_ID:41672 EP_NO: N/A Repair Type: Non-Urgent Crossing Status: Indicator Found UCIP Comments: 09/17/2013 Verify Pipe is abandoned or still intact.- may be this crossing was abandoned/removed during recent levee reconstruction.- no signs of pipe and appurtenances on waterside.- only a CM pipe riser with slide gate found on landside. (DWR UCIP - P. Amatya) FIELD_STRUCT_DESC: 36-inch corrugated metal irrigation pipe through the levee, 10 feet below the crown. Riser on the landside (LS). Screw gate in a 48-inch pipe well on the waterside (WS) slope. Concrete headwall and cobble spillway at the LS toe. Concrete headwall at the WS toe. [Additional Reference(s): USACE San Joaquin O&M Manual 607, June 1962, (HLM 1.32)]. FS Date: 9/17/2013

LS view: overview of CM pipe riser with slide gate. Dense vegetation on landside.

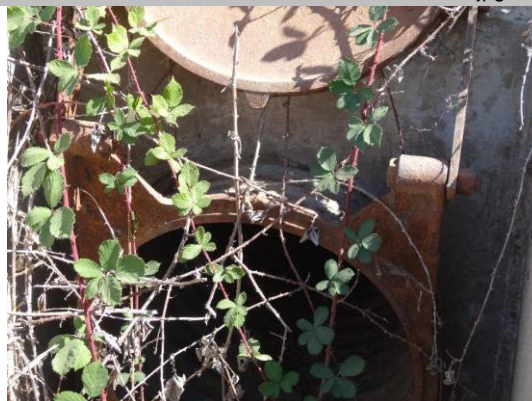
Photo 2 of 3 : UCIP\_SP\_2020\_50156\_35244.jpg

WS view: U typed concrete headwall, CM pipe, and flap gate. Flap gate was not closed. Vegetation needs to be cleared.

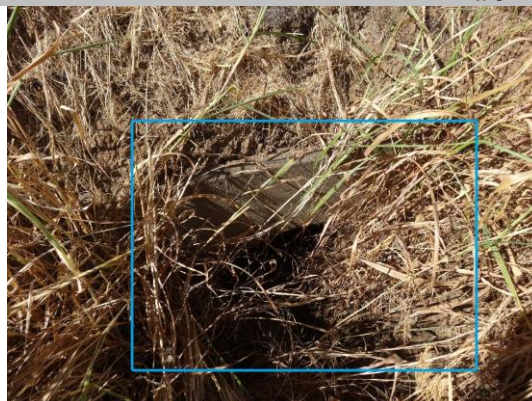
Photo 3 of 3 : UCIP\_SP\_2020\_50156\_35246.jpg

LS view: concrete headwall and CM pipe. Inlet needs cleaning.

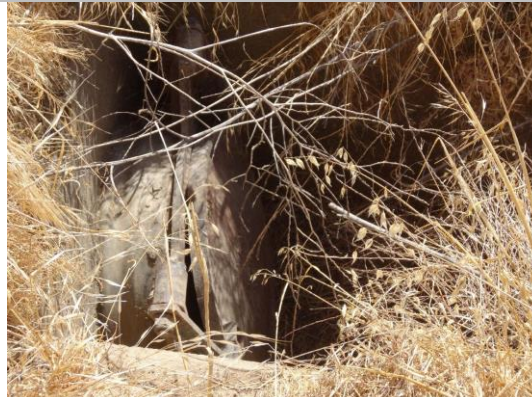
Photo 2 of 3 : UCIP\_SP\_2020\_20946\_35265.jpg

WS view: U typed concrete headwall, CM pipe, and flap gate. Flap gate was not properly closed.

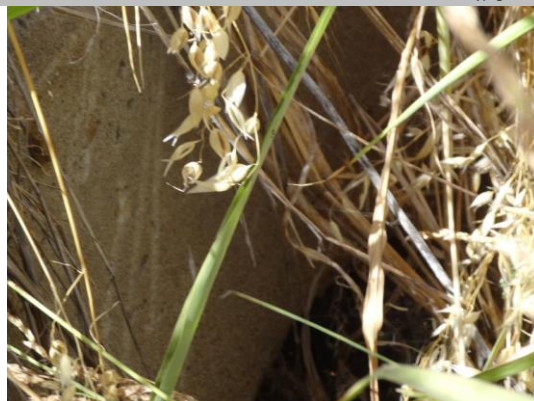
Photo 3 of 3 : UCIP\_SP\_2020\_20946\_35264.jpg

LS view: concrete headwall and CM pipe. Inlet needs cleaning.

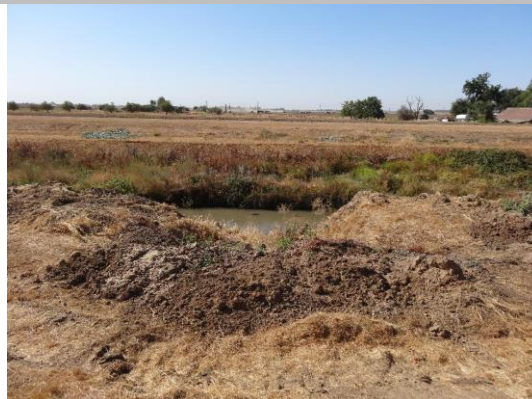
Photo 1 of 3 : UCIP\_SP\_2020\_20992\_35370.jpg

Comment Code					
Inspector Comment					
DS_ID:23055 FS_ID:20992 EP_NO: N/A Repair Type: Non-Urgent Crossing Status: Found UCIP Comments: 09/17/2013 - mud and debris from recent channel cleaning needs to be removed from spillway and outlet - pipe filled with debris, it needs cleaning.- half of intet pipe burried. (DWR UCIP - P. Amatya) FIELD_STRUCT_DESC: 24-inch corrugated metal gravity drainage pipe through the levee, 8 feet below the crown. Concrete headwall, flap gate, and concrete grouted cobble spillway on the waterside (WS) toe. Concrete headwall on the landside (LS) toe. [Additional Reference(s): DWR Levee Log, 2005. USACE San Joaquin O&M Manual 607, June 1962, (HLM 0.73)]. FS Date: 9/17/2013

WS view: concrete headwall and CM pipe buried under debris and mud.

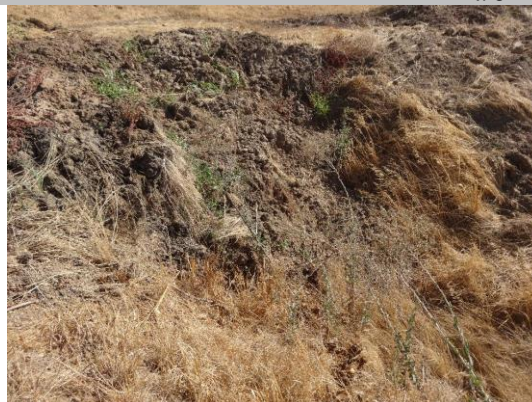
Photo 2 of 3 : UCIP\_SP\_2020\_20992\_35369.jpg

WS view: debris and mud deposited from the channel cleaning. It needs to be cleared from spillway and outlet structure.

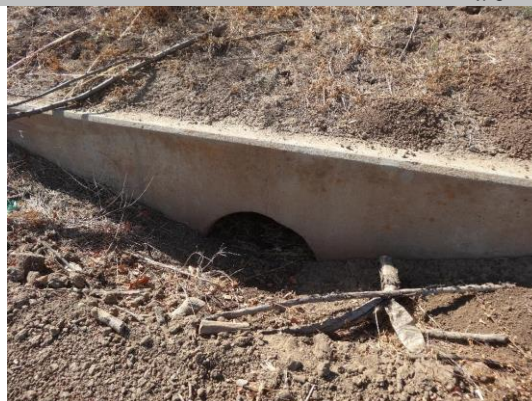
Photo 3 of 3 : UCIP\_SP\_2020\_20992\_35366.jpg

LS view: concrete headwall and CM pipe. Half of intet pipe burried.

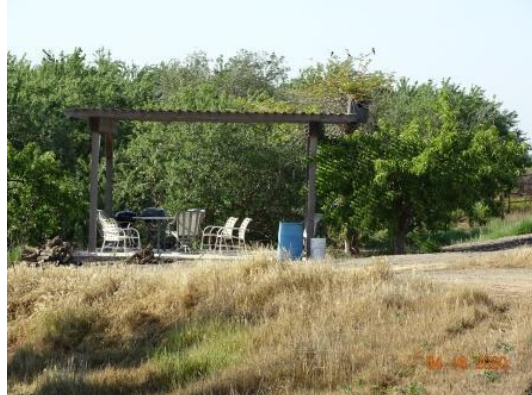
Photo 1 of 1 : SP\_2020\_NA0013\_332\_24\_20200505\_00050.jpg

Unauthorized patio and fruit trees installed on the landside slope.  
(Spring 2020)

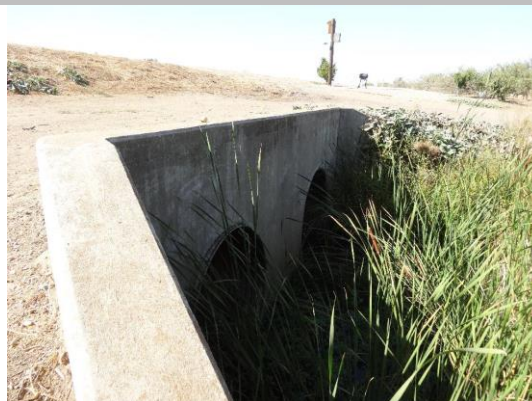
Photo 3 of 3 : UCIP\_SP\_2020\_20965\_35290.jpg

LS view: two CM pipes and U typed headwall on levee toe. Green vegetation in drainage channel.

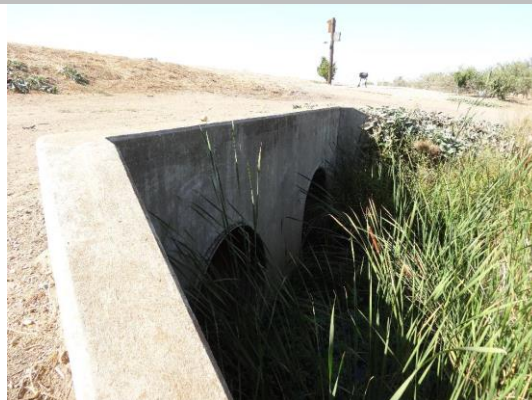
Photo 2 of 3 : UCIP\_SP\_2020\_20983\_35301.jpg

LS view: U typed concrete headwall, two CMPs in drainage ditch. Dense vegetation in drainage ditch.

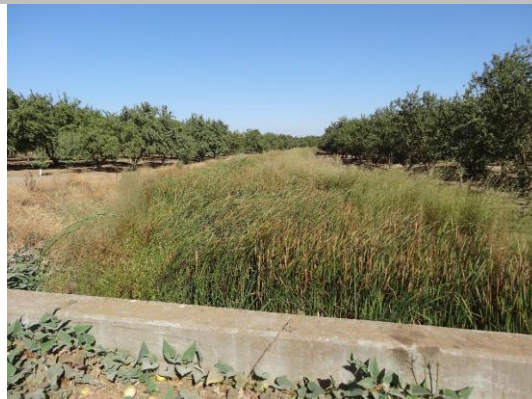
Photo 3 of 3 : UCIP\_SP\_2020\_20983\_35300.jpg

LS view: concrete headwall in drainage ditch. Dense vegetation in drainage ditch.

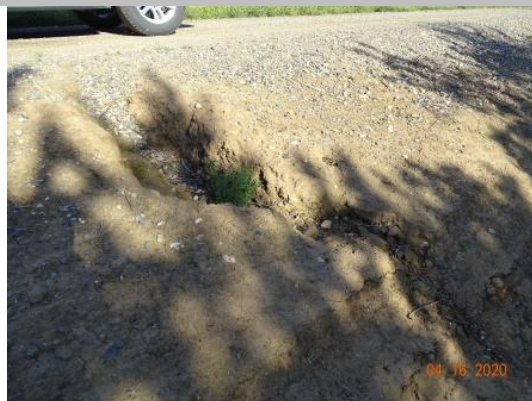
Photo 1 of 1 : SP\_2020\_NA0013\_332\_15\_20200505\_00049.jpg

LM Start	0.97	Rating **	M	Issue No.	15
LM End	0.97	Issue Type +	Ma	Location *	LS
Category	Earthen Levee			GPS Latitude/Longitude	
				Start	End
Item	Erosion / Bank Caving			37.327336 °	37.327336 °
				-120.396085 °	-120.396085 °
DWR ID	DWR_NA0013_02_f_2017_15				
Comment Code					
E2 : Schedule repair of erosion site prior to the next inspection.					
Inspector Comment					
There is large finger erosion on the landward slope. Couple of smaller erosion sites are starting just downstream of the larger erosion.

Looking at finger erosion on the landside slope. (Spring 2020)

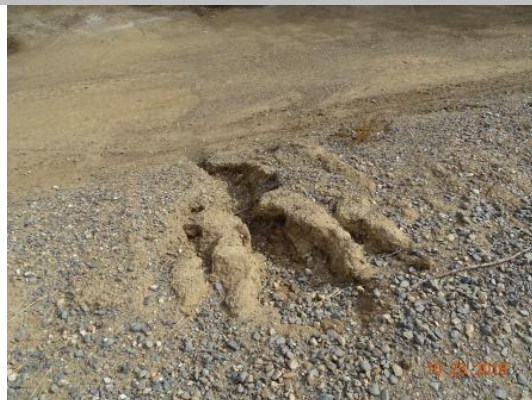
Photo 1 of 1 : SP\_2020\_NA0013\_332\_16\_20200225\_00012.jpg

LM Start	1.10	Rating **	M	Issue No.	16
LM End	1.10	Issue Type +	Ma	Location *	LS
Category	Earthen Levee			GPS Latitude/Longitude	
				Start	End
Item	Erosion / Bank Caving			37.325487 °	37.325487 °
				-120.396052 °	-120.396052 °
DWR ID	DWR_NA0013_02_s_2017_16				
Comment Code					
E2 : Schedule repair of erosion site prior to the next inspection.					
Inspector Comment					
Large finger erosion is located on the landside slope.

View of large finger erosion in landside slope. (Fall 2018)

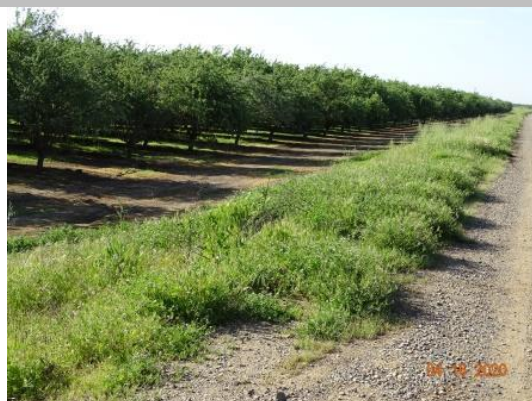
Photo 1 of 1 : SP\_2020\_NA0013\_332\_29\_20200505\_00053.jpg

Control vegetation along the landside shoulder and slope. (Spring 2020)

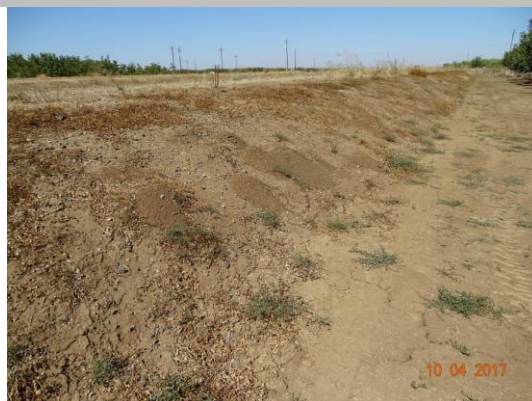
Photo 1 of 1 : SP\_2020\_NA0013\_332\_18\_20200225\_00015.jpg

View of rodent activity on the landside slope.

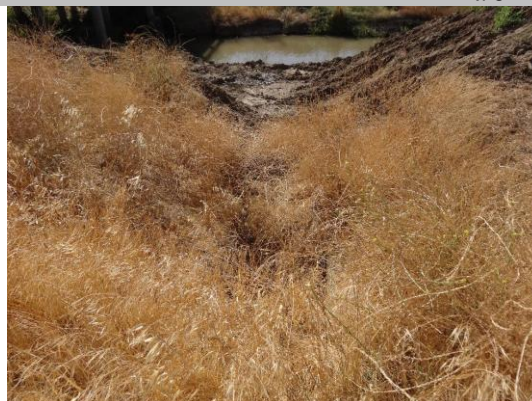
Photo 1 of 3 : UCIP\_SP\_2020\_42993\_35310.jpg

DS\_ID:23058  
 FS\_ID:42993  
 EP\_NO: N/A  
 Repair Type: Non-Urgent  
 Crossing Status: Found  
 UCIP Comments: 09/17/2013 - needs cleaning of debris on spillway on WS. Flapgate blocked by debris on WS. - needs cleaning inside CMP on LS. (DWR UCIP - P. Amatya)  
 FIELD\_STRUCT\_DESC: 24-inch corrugated metal gravity drainage pipe through the levee, 8 feet below the crown. Concrete headwall, flap gate, and concrete grouted cobble spillway on the waterside (WS) toe. Concrete headwall on the landside (LS) toe. [Additional Reference(s): DWR Levee Log, 2005. USACE San Joaquin O&M Manual 607, June 1962, (HLM 1.64)].  
 FS Date: 9/17/2013

WS view: overview of outlet area and channel. Debris and vegetations on spillway.

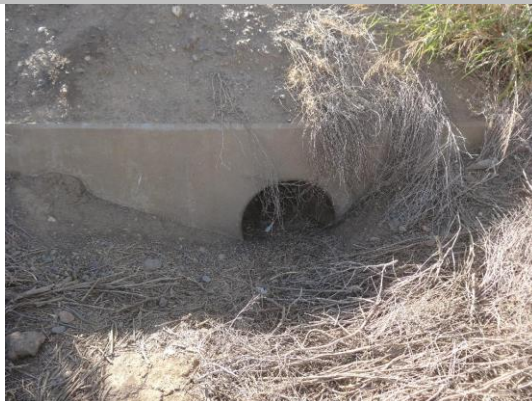
Photo 3 of 3 : UCIP\_SP\_2020\_42993\_35312.jpg

LS view: concrete headwall and CM pipe. Inlet needs cleaning. Part of inlet pipe buried.

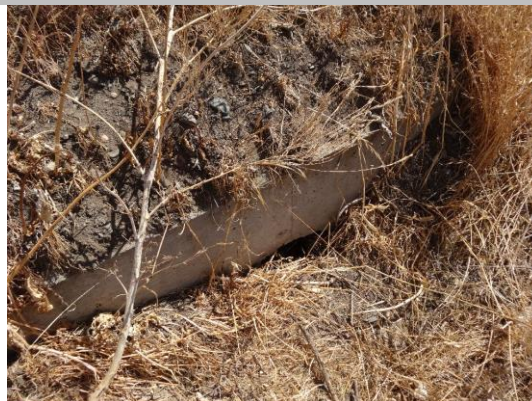
Photo 3 of 3 : UCIP\_SP\_2020\_41815\_35531.jpg

LS view: concrete headwall and CM pipe. Inlet needs cleaning and silt removed.

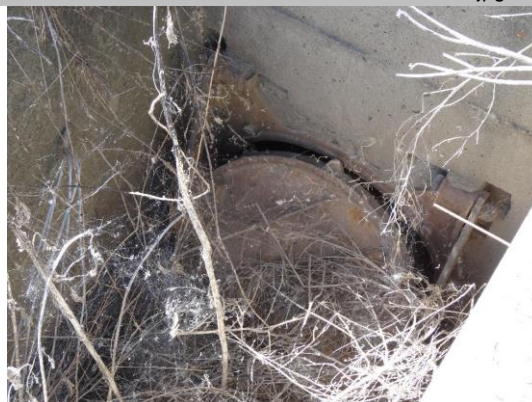
Photo 2 of 3 : UCIP\_SP\_2020\_50144\_35421.jpg

WS view: U typed concrete headwall, CM pipe, and flap gate. Damaged flap gate.

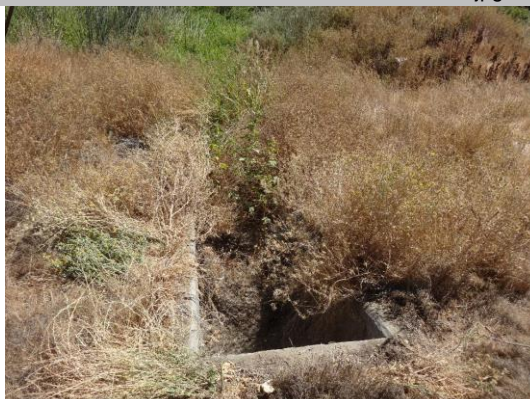
Photo 1 of 3 : UCIP\_SP\_2020\_50149\_35535.jpg

WS view: cobble spillway and channel on waterside. Dense vegetation on levee slope.

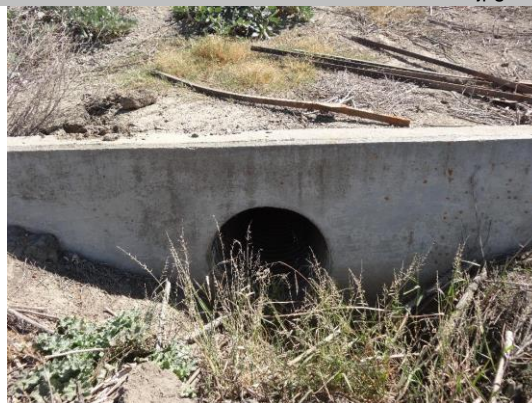
Photo 3 of 3 : UCIP\_SP\_2020\_50149\_35537.jpg

LS view: concrete headwall and CM pipe. Inlet needs clearing.

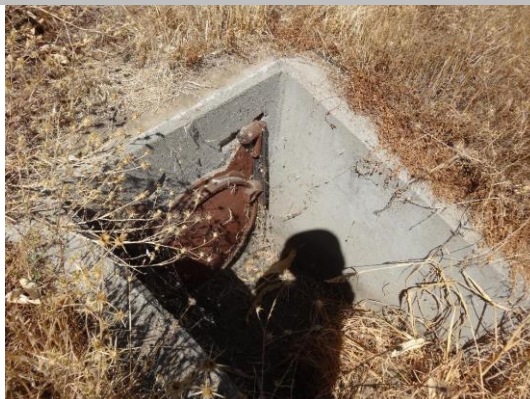
Photo 2 of 3 : UCIP\_SP\_2020\_50151\_35538.jpg

WS view: U typed concrete headwall, CM pipe, and flap gate. Vegetation needs to be cleared.

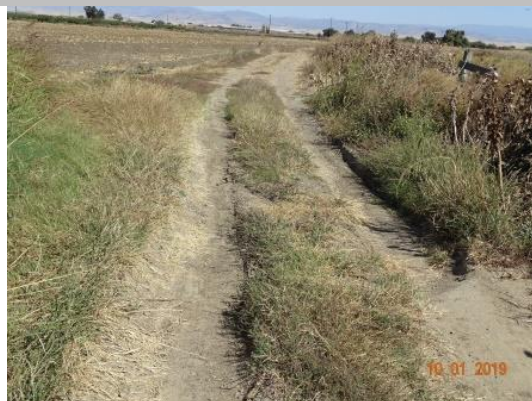
Photo 1 of 1 : SP\_2020\_NA0013\_333\_9\_20200225\_00001.jpg

View of rutted levee crown looking upstream. (Fall 2019)

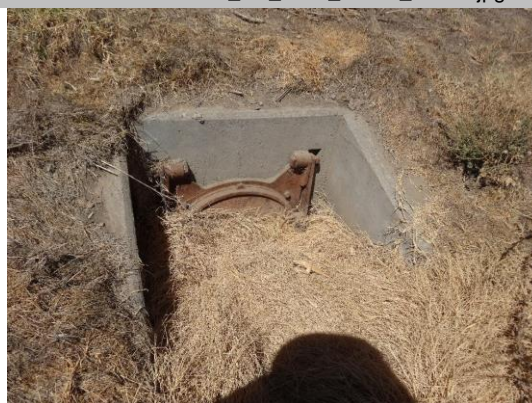
Photo 2 of 3 : UCIP\_SP\_2020\_50152\_35543.jpg

WS view: U typed concrete headwall, CM pipe, and flap gate. Vegetation needs to be cleared.

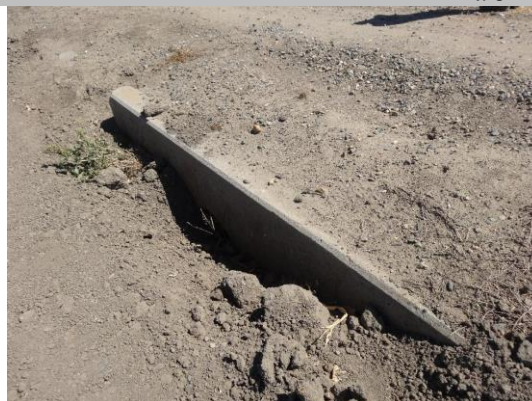
Photo 3 of 3 : UCIP\_SP\_2020\_50152\_35542.jpg

LS view: concrete headwall and CM pipe. Inlet needs clearing &amp;

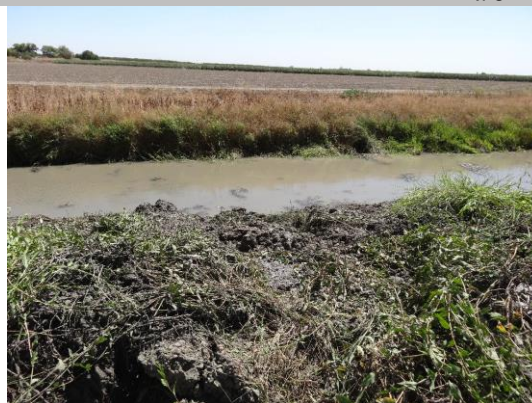
Photo 1 of 3 : UCIP\_SP\_2020\_21063\_35502.jpg

WS view: U typed concrete headwall, CM pipe, and flap gate buried under mud/debris.

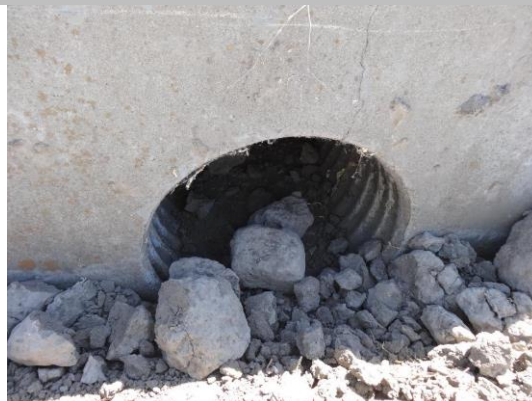
Photo 3 of 3 : UCIP\_SP\_2020\_21063\_35500.jpg

LS view: closer view of CM pipe. Inlet needs cleaning &amp; clearing.

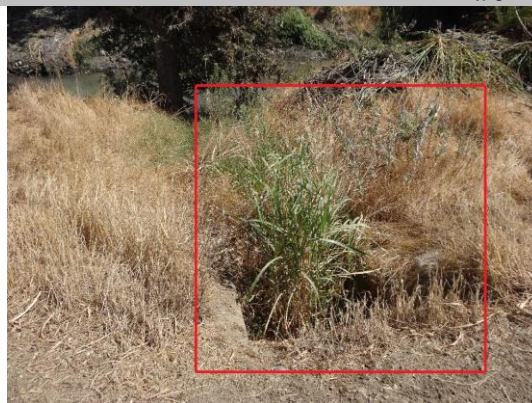
Photo 1 of 3 : UCIP\_SP\_2020\_21064\_35506.jpg

WS view: cobble spillway and channel on waterside. Dense vegetation on levee slope and spillway.

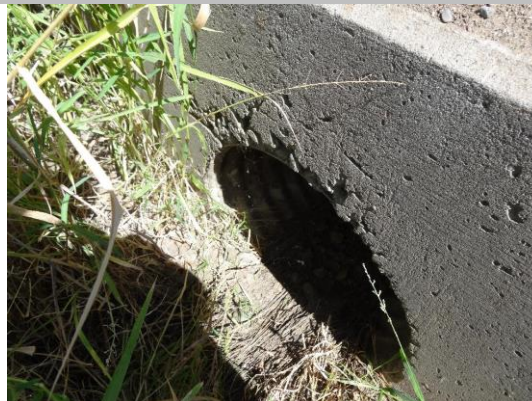
Photo 3 of 3 : UCIP\_SP\_2020\_21064\_35504.jpg

LS view: concrete headwall and CM pipe. Inlet needs clearing.

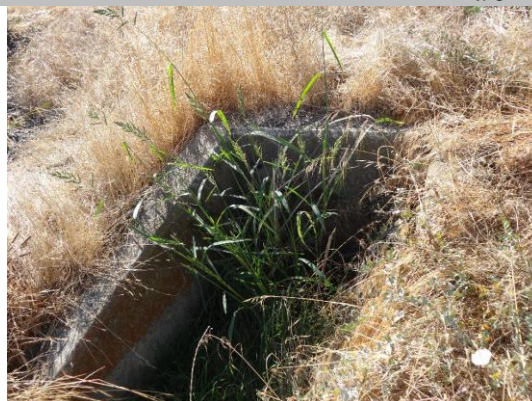
Photo 1 of 3 : UCIP\_SP\_2020\_42991\_35751.jpg

WS view: concrete spillway and channel on waterside. Dense vegetation on levee slope and spillway.

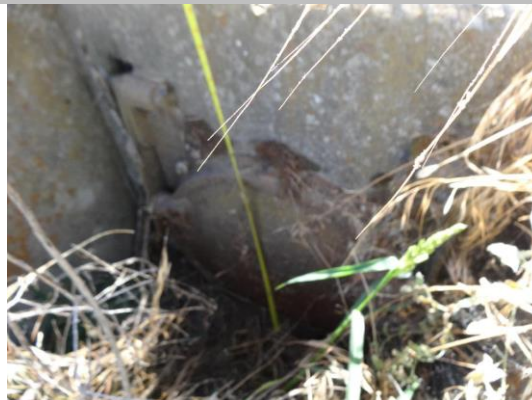
Photo 2 of 3 : UCIP\_SP\_2020\_42991\_35750.jpg

WS view: U typed concrete headwall, CM pipe, and flap gate. Vegetation and silt need to be cleared.

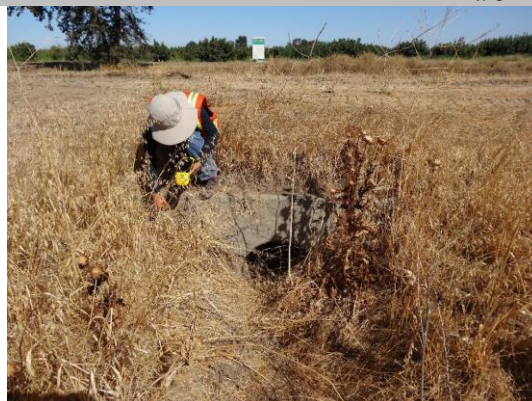
Photo 3 of 3 : UCIP\_SP\_2020\_42991\_35749.jpg

LS view: concrete headwall and CM pipe. Inlet silt needs clearing.

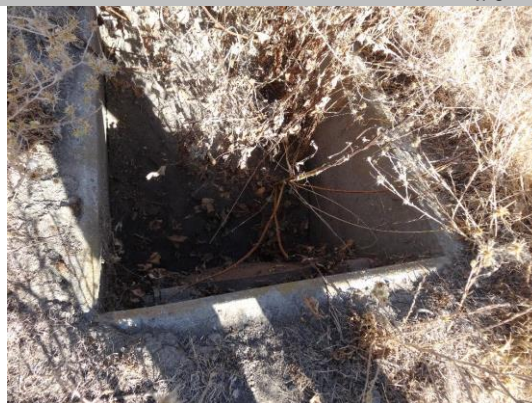
Photo 1 of 3 : UCIP\_SP\_2020\_50146\_35748.jpg

WS view: U typed concrete headwall, CM pipe, and flap gate. Vegetation needs to be cleared.

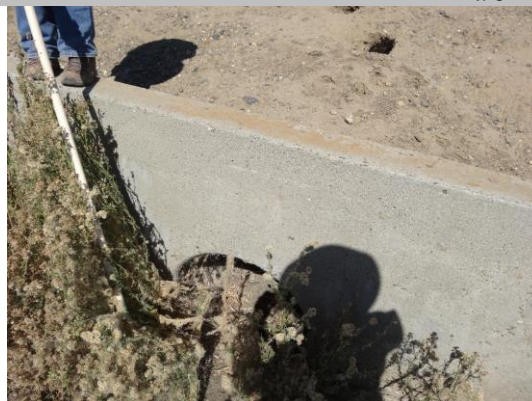
Photo 2 of 3 : UCIP\_SP\_2020\_50146\_35747.jpg

LS view: concrete headwall and CM pipe. Inlet needs clearing.

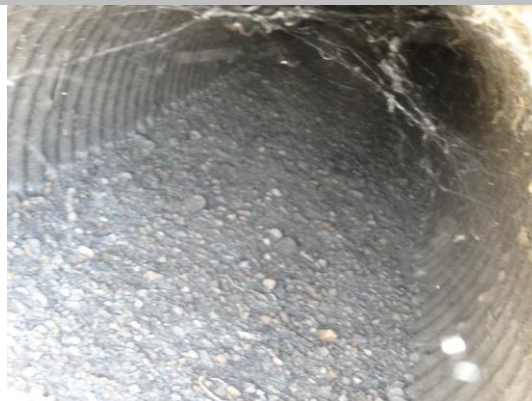
Photo 3 of 3 : UCIP\_SP\_2020\_50146\_35746.jpg

LS view: inside view of CM pipe. Inlet pipe needs clearing.

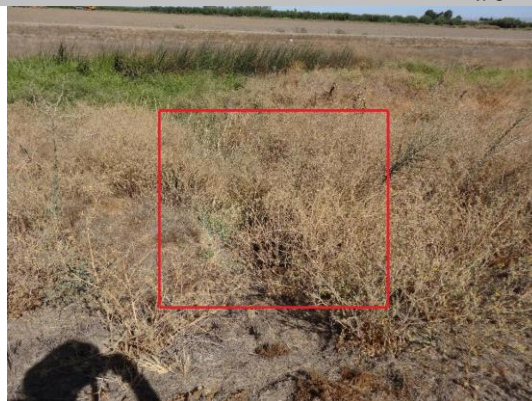
Photo 1 of 3 : UCIP\_SP\_2020\_50154\_35608.jpg

WS view: Dense vegetation on levee slope and spillway.

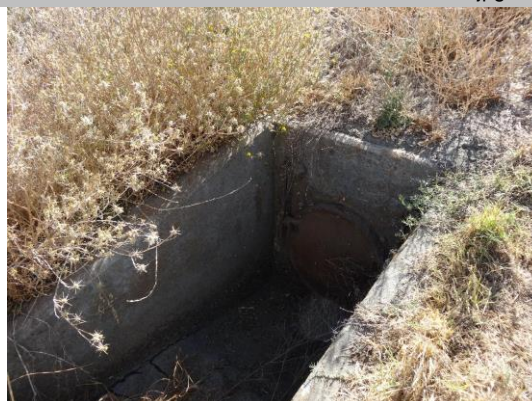
Photo 2 of 3 : UCIP\_SP\_2020\_50154\_35607.jpg

WS view: U typed concrete headwall, CM pipe, and flap gate. Vegetation needs to be cleared on spillway.

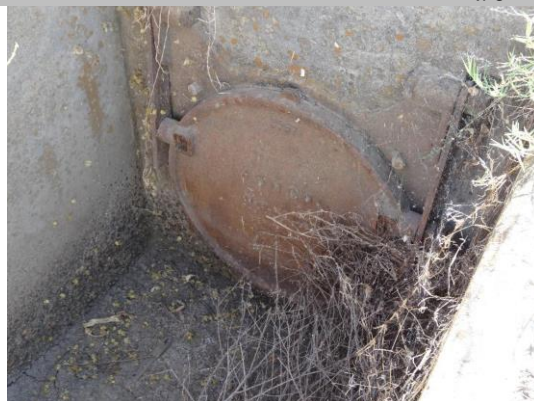
Photo 3 of 3 : UCIP\_SP\_2020\_50154\_35606.jpg

WS view: CM pipe and flap gate. Vegetation needs to be cleared.

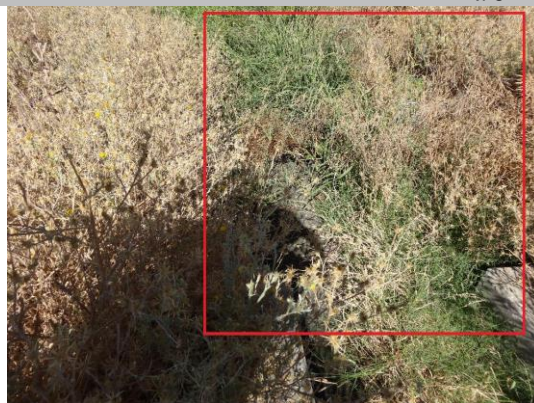
Photo 1 of 3 : UCIP\_SP\_2020\_50148\_35613.jpg

WS view: Dense vegetation on levee slope and spillway.

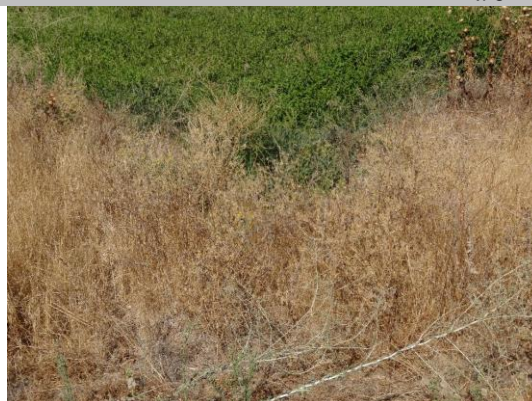
Photo 1 of 3 : UCIP\_SP\_2020\_50155\_35642.jpg

WS view: Dense vegetation on levee slope and spillway.

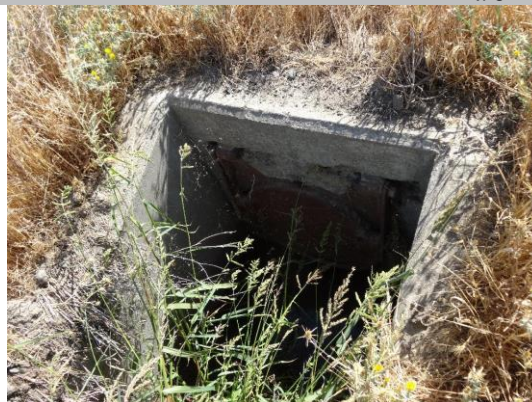
Photo 2 of 3 : UCIP\_SP\_2020\_50155\_35641.jpg

WS view: U typed concrete headwall, CM pipe, and flap gate. Vegetation needs to be cleared.

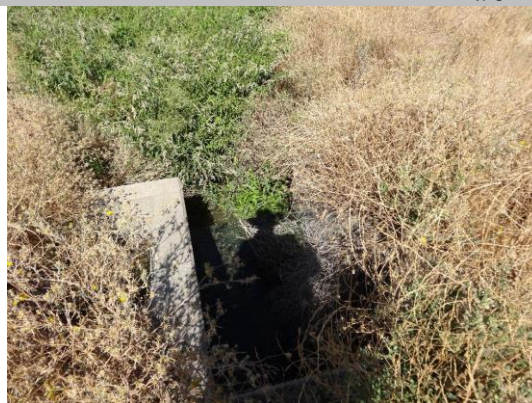
Photo 1 of 3 : UCIP\_SP\_2020\_21126\_35652.jpg

WS view: concrete spillway and channel on waterside. Dense vegetation on levee slope and spillway.

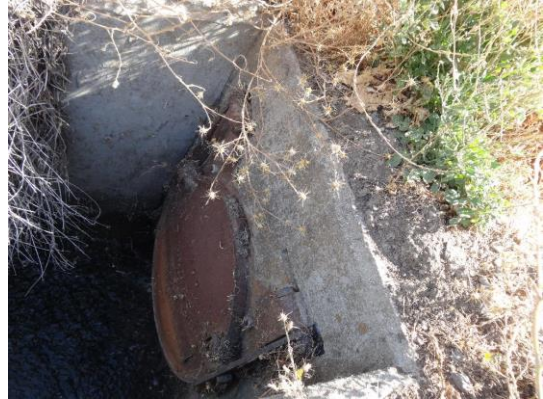
Photo 2 of 3 : UCIP\_SP\_2020\_21126\_35651.jpg

WS view: U typed concrete headwall, CM pipe, and flap gate. Vegetation needs to be cleared on spillway.

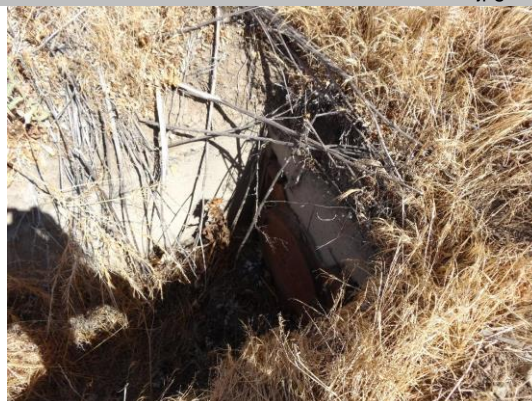
Photo 1 of 3 : UCIP\_SP\_2020\_52888\_35709.jpg

WS view: concrete spillway and channel on waterside. Dense vegetation on levee slope and spillway.

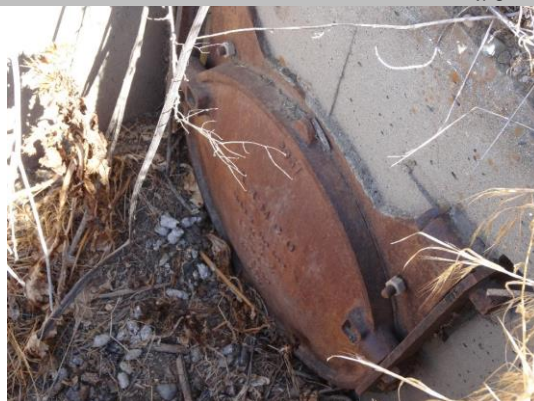
Photo 2 of 3 : UCIP\_SP\_2020\_52888\_35708.jpg

WS view: U typed concrete headwall, CM pipe, and flap gate. Spillway needs to be cleared.

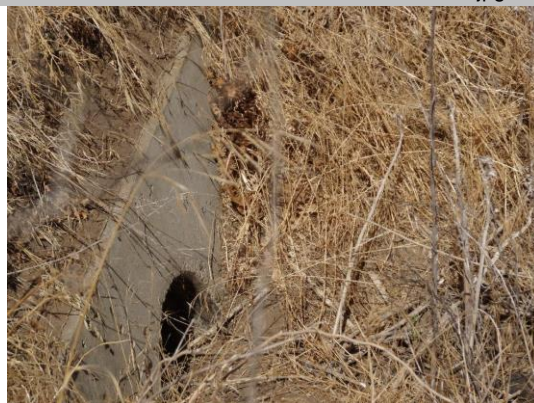
Photo 3 of 3 : UCIP\_SP\_2020\_52888\_35707.jpg

LS view: concrete headwall and CM pipe. Inlet silt needs clearing.

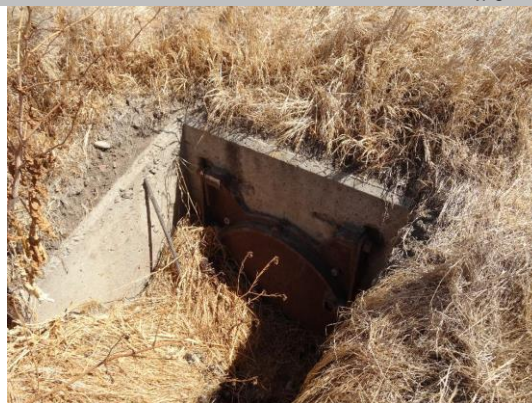
Photo 1 of 3 : UCIP\_SP\_2020\_50153\_35745.jpg

WS view: U typed concrete headwall, CM pipe, and flap gate. Dirt and vegetations need to be removed and cleared.

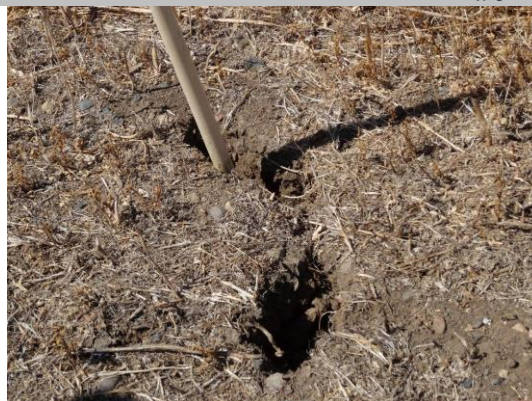
Photo 2 of 3 : UCIP\_SP\_2020\_50153\_35744.jpg

WS view: significant levee cracks along the pipe alignment. Needs detailed investigation on the issue.

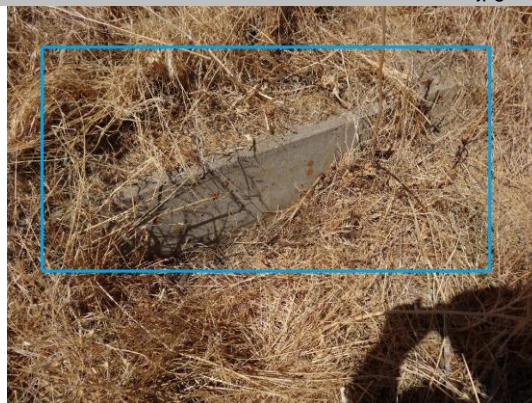
Photo 3 of 3 : UCIP\_SP\_2020\_50153\_35743.jpg

LS view: concrete headwall and buried CM pipe. Dirt removal and clearing needed in inlet.
